# Wetland Delineation Report

Runway 11-29 Safety Improvements, Off Airport Tree Removal  
and Airfield Pavement Rehabilitation Projects

Igor I. Sikorsky Memorial Airport  
Stratford, Connecticut

November 2021

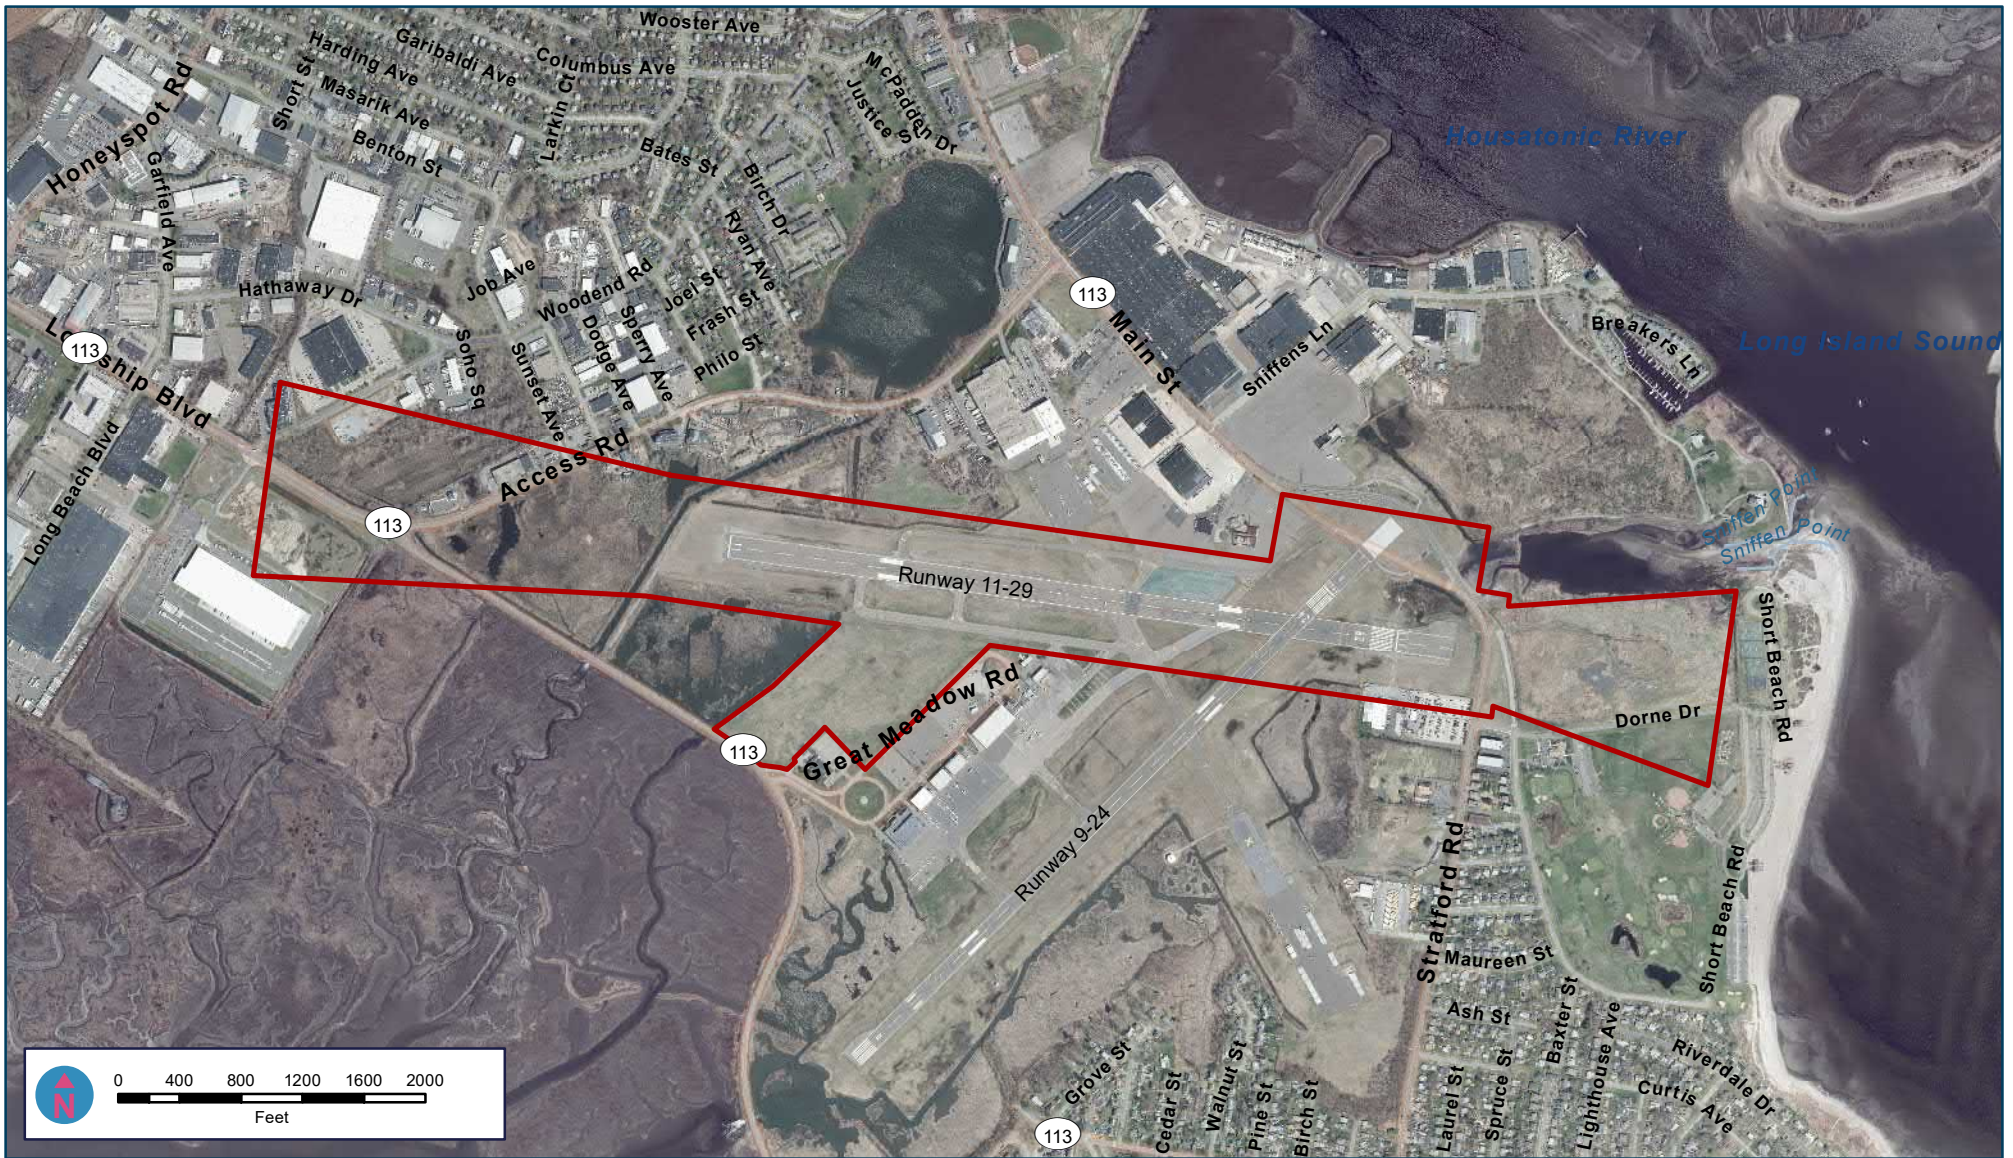
Figure 1 - Overview Map

Igor I. Sikorsky Memorial Airport (the Airport) is a public airport in the Town of Stratford owned and operated by the City of Bridgeport (see **Figure 1, Project Overview Map** and **Figure 2, USGS Map in Appendix A**). The City of Bridgeport is proposing safety improvements to the existing crosswinds runway known as Runway 11-29.

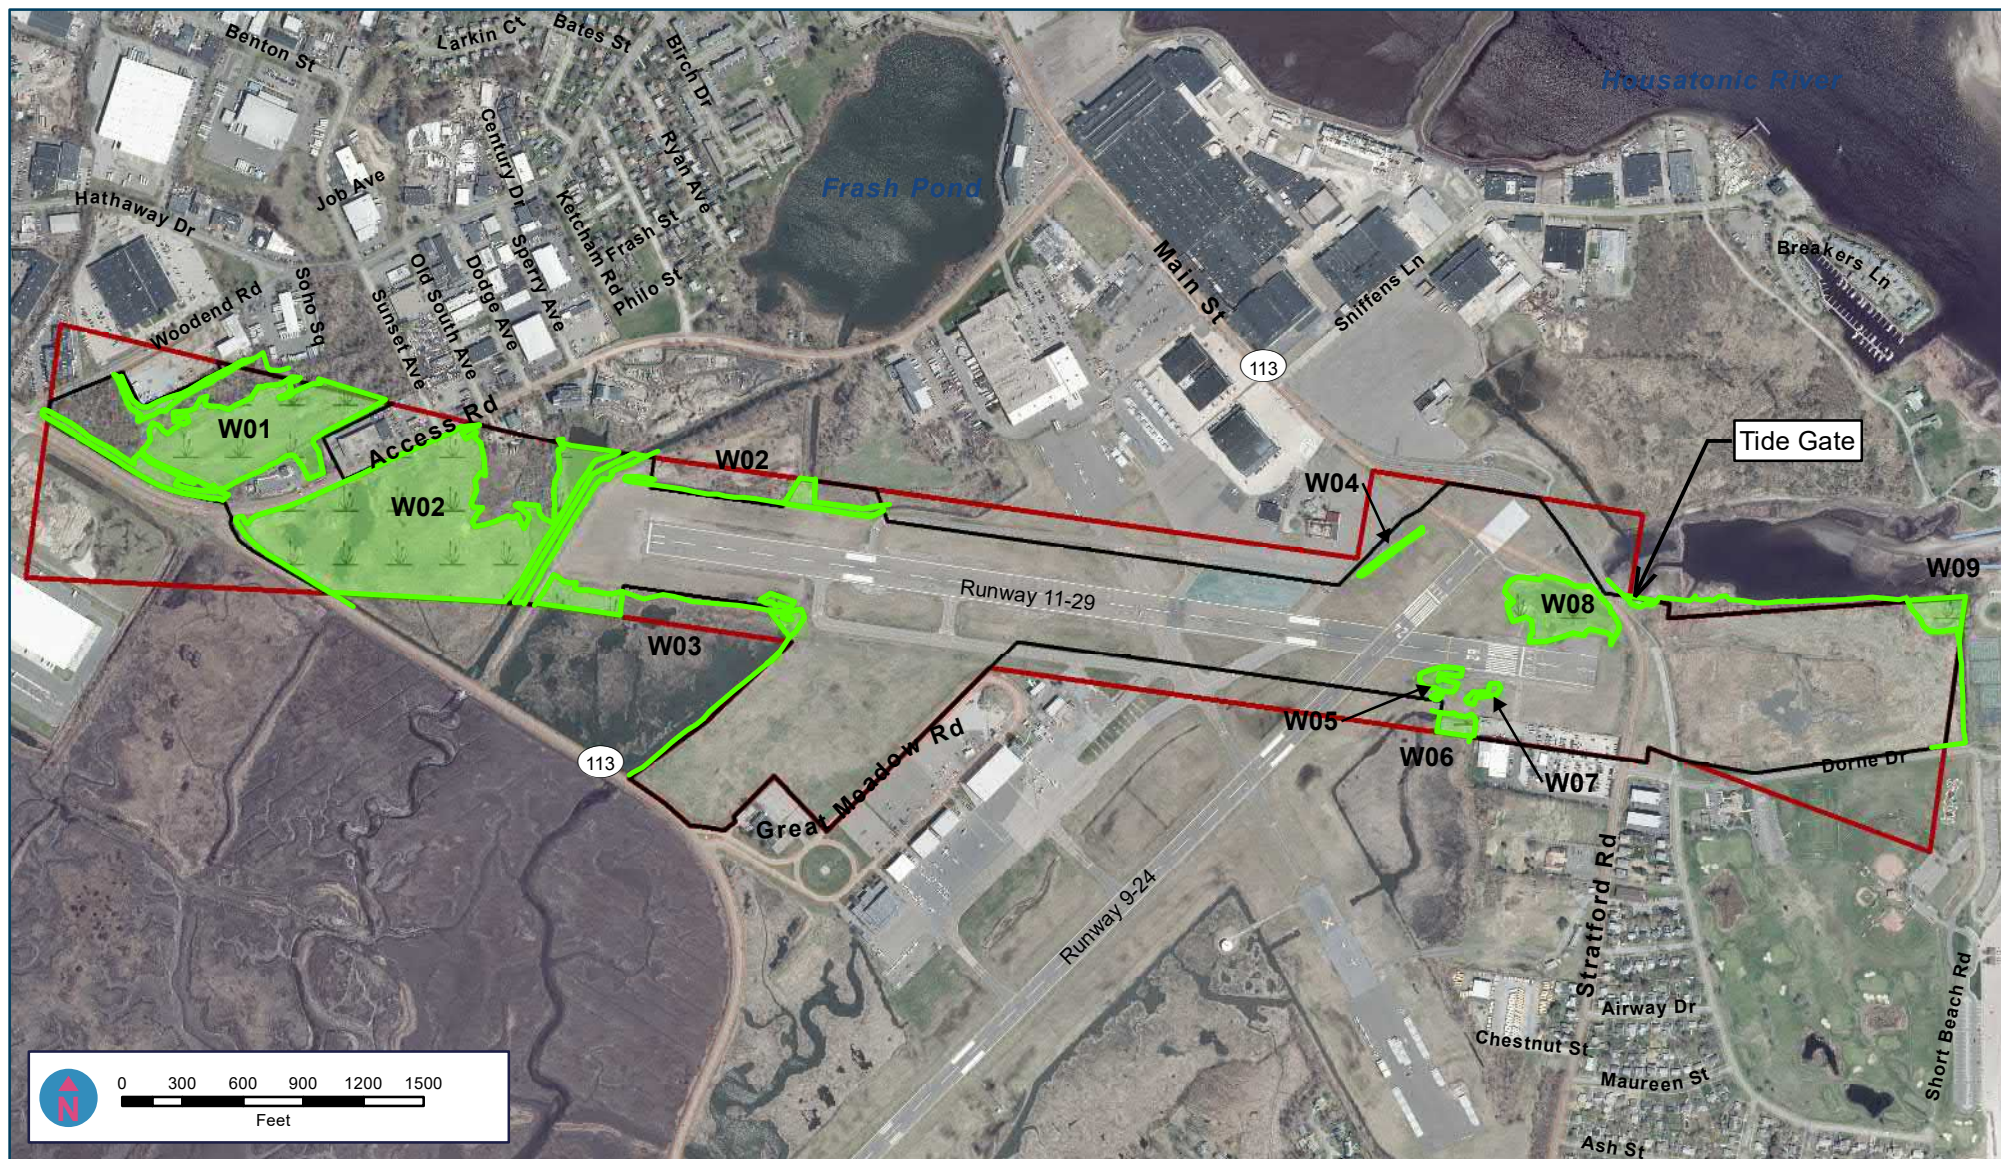
Figure 3 - Wetland Resources

The delineated wetland systems are numbered 1 to 9 from west to east (see **Figure 3, Wetland Map in Appendix A**). All of the wetlands on the site are tidal wetlands, most of which have been disturbed by past and present disturbance. Wetland systems 1, 2 and 3 drain to the west and are within the Southwest Coast major basin, Southwest Eastern regional basin, Lewis Gut subregional basin and Local Basin Number 7102-00 (CT Environmental Conditions Online, Advanced Viewer, 2021). Wetlands 4, 5, 6, 7, 8 and 9 drain to the east and are within the Southwest Coast major basin, Southwest Eastern regional basin, Housatonic River subregional basin and Local Basin Number 6000-90. The CJL elevation for the site is 4.8 feet NAVD88. General descriptions of these nine wetlands are provided below, with additional detailed information for each wetland in **Table 1**.

Wetland 1 and Wetland 2 are extensive tidal marshes in the western portion of the project area where tree obstruction removal is proposed. These wetlands have been altered by past practices of filling and channelization. Typically, these wetlands contain mosquito ditches and upland dikes comprised of side cast dredge spoils adjacent to the excavated tidal creeks. Wetland 1 is located off the Airport property, and although shown as inland wetland by the NWI (see **Figure 4**), it is actually tidally connected via a culvert under Access Road. The tidal creek flows under Access Road from Wetland 1, just east of the intersection with Lordship Boulevard to Wetland 2. The smaller tidal creeks within Wetland 2 all ultimately drain to a larger tidal creek that flows under Lordship Boulevard, draining south to a large tidal marsh adjacent to Lewis Gut. Wetland 2 includes the excavated channel on the north side of the west end of Runway 11-29.

Wetland 3 is adjacent to the mowed areas south of the west end of Runway 11-29. Wetland 3 is part of a larger wetland complex that extends south to Lordship Boulevard. Wetland 3 ultimately drains to the southwest to a tidal creek that flows under Lordship Boulevard ultimately to Lewis Gut. Wetland 3 contains the State-special concern plant species Needlegrass (*Aristida longespica*).

Wetland 4 is a relatively narrow, *Phragmites*-dominated, excavated channel to the north of the intersection of Runway 11-29 and Runway 9-24. The channel was constructed in 2015 to convey drainage from the airport mowed areas off site. Wetland 4 is tidally influenced, and fish were observed during field work. Wetland 5 and Wetland 7 are isolated wetlands entirely within the mowed area south of the east end of Runway 9-24. Wetland 5 contains the State-endangered plant Salt Pond Grass (*Leptochloa fusca*), and Wetland 7 contains the State-special concern plant Needlegrass (*Aristida longespica*). Wetland 6 is a *Phragmites*-dominated wetland located south of the east end of Runway 11-29.

Wetland 8 is located adjacent to the north side of the east end of Runway 11-29. Wetland 8 is an emergent tidal wetland with an excavated creek that flows to the east under Stratford Road (Route 113) to Wetland 9. Portions of Wetland 8 are actively mowed. Wetland 8 contains the State-special concern plant Seaside Orach (*Atriplex glabriuscula*).

Wetland 9 is located on the east side of Stratford Road, off Airport property, where tree obstruction removal is proposed. A tidal creek flows from under Stratford Road to Marine Basin. Tide gates have been installed on the east side of Stratford Road. Wetland 9 includes a narrow strip of tidal vegetation on the south side of a cove along the Housatonic River known on topographic maps as the “Marine Basin” and a tidal channel along the east side of the limit of wetland fieldwork. Marine Basin is connected to the Housatonic River via a tidal creek, with a tide gate on the east side of Route 113.

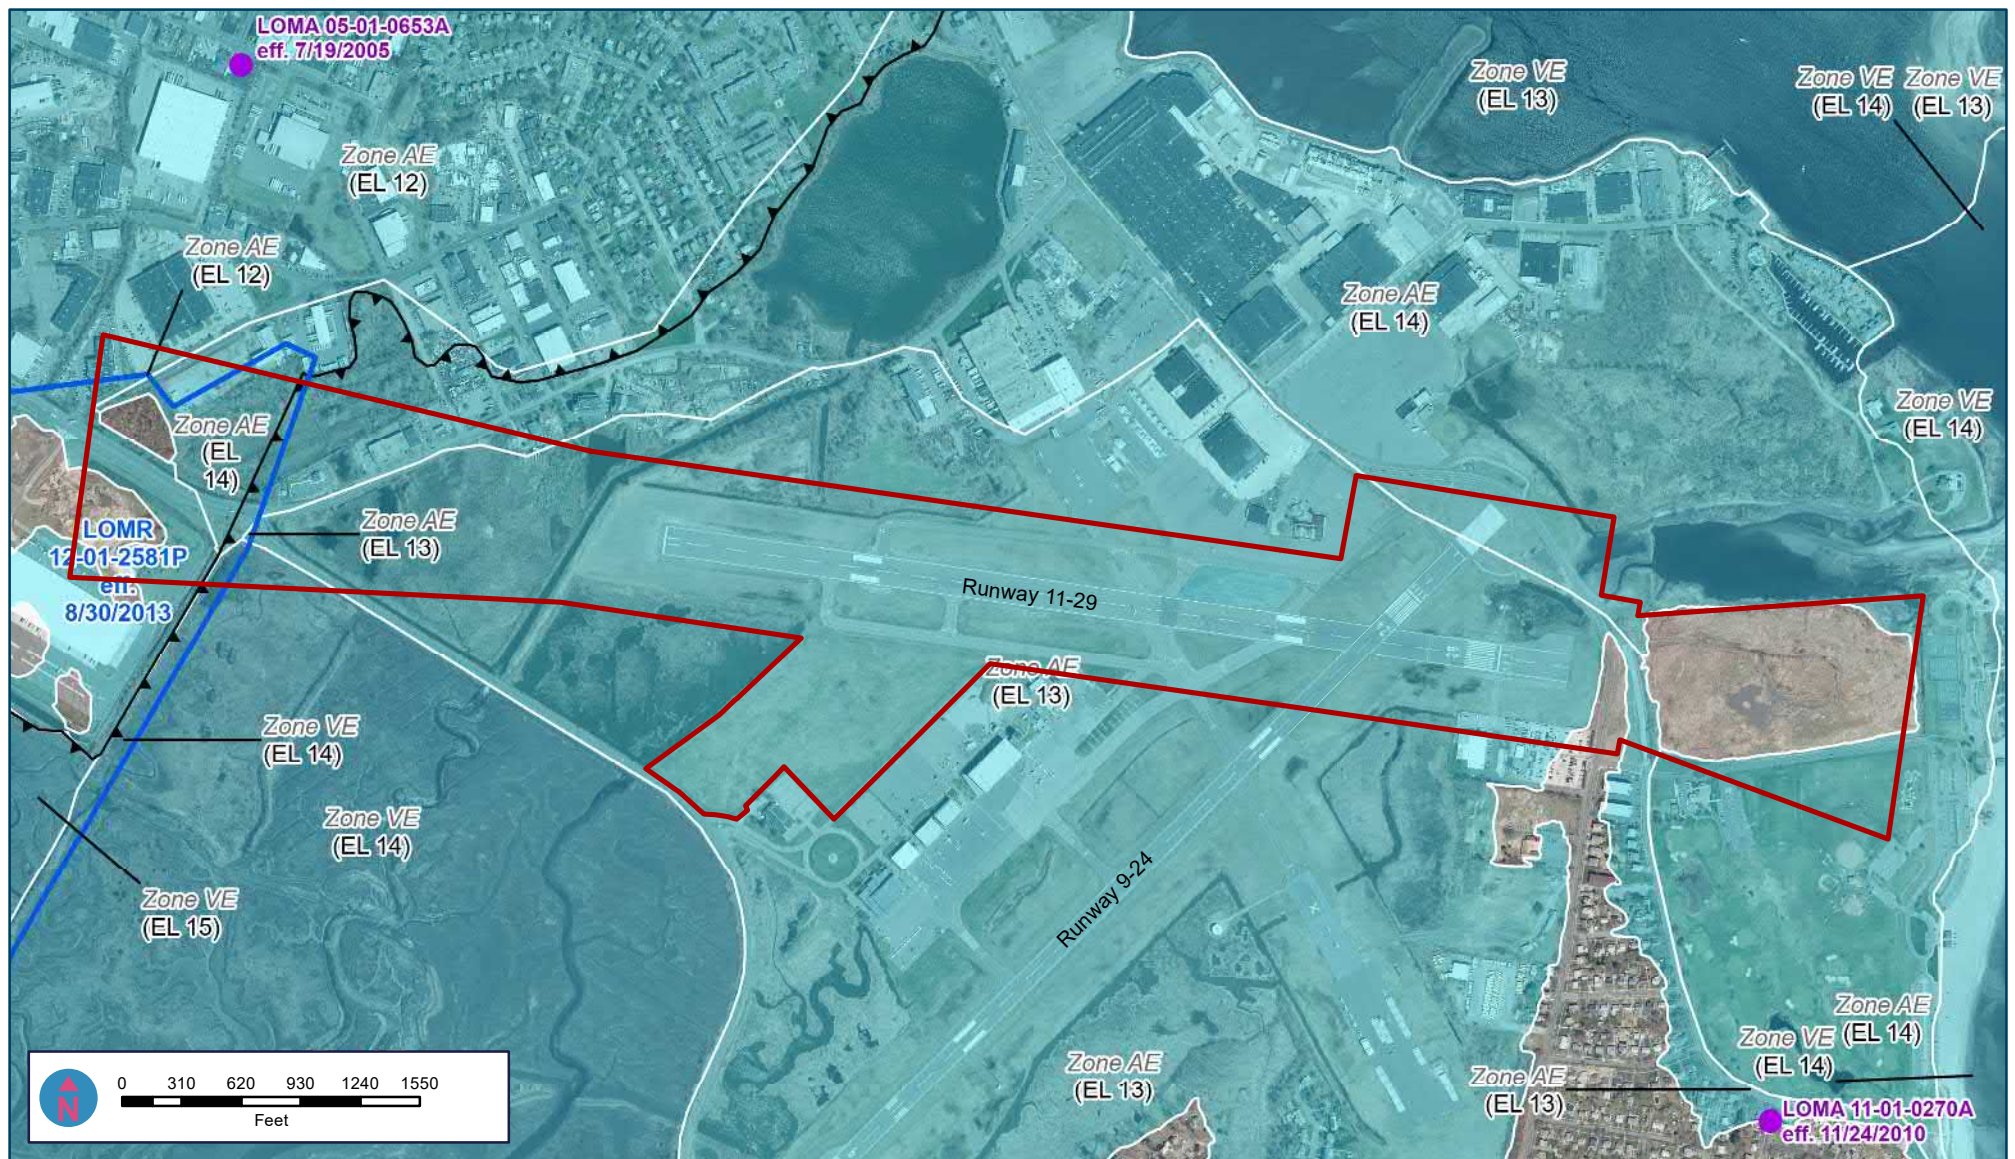
Figure 5 - FEMA Flood Hazard Areas

The wetland ID/flagging sequence, wetland type, soil type and characteristic vegetation of each of the nine wetlands is summarized in **Table 1**. Additionally, the United States Fish and Wildlife Service (USFWS), National Wetland Inventory (NWI) map and Federal Emergency Management Agency (FEMA) floodplain map are included as **Figure 4** and **Figure 5**, respectively, in **Appendix A**. Most of the project area is located within the 100-year floodplain limits.

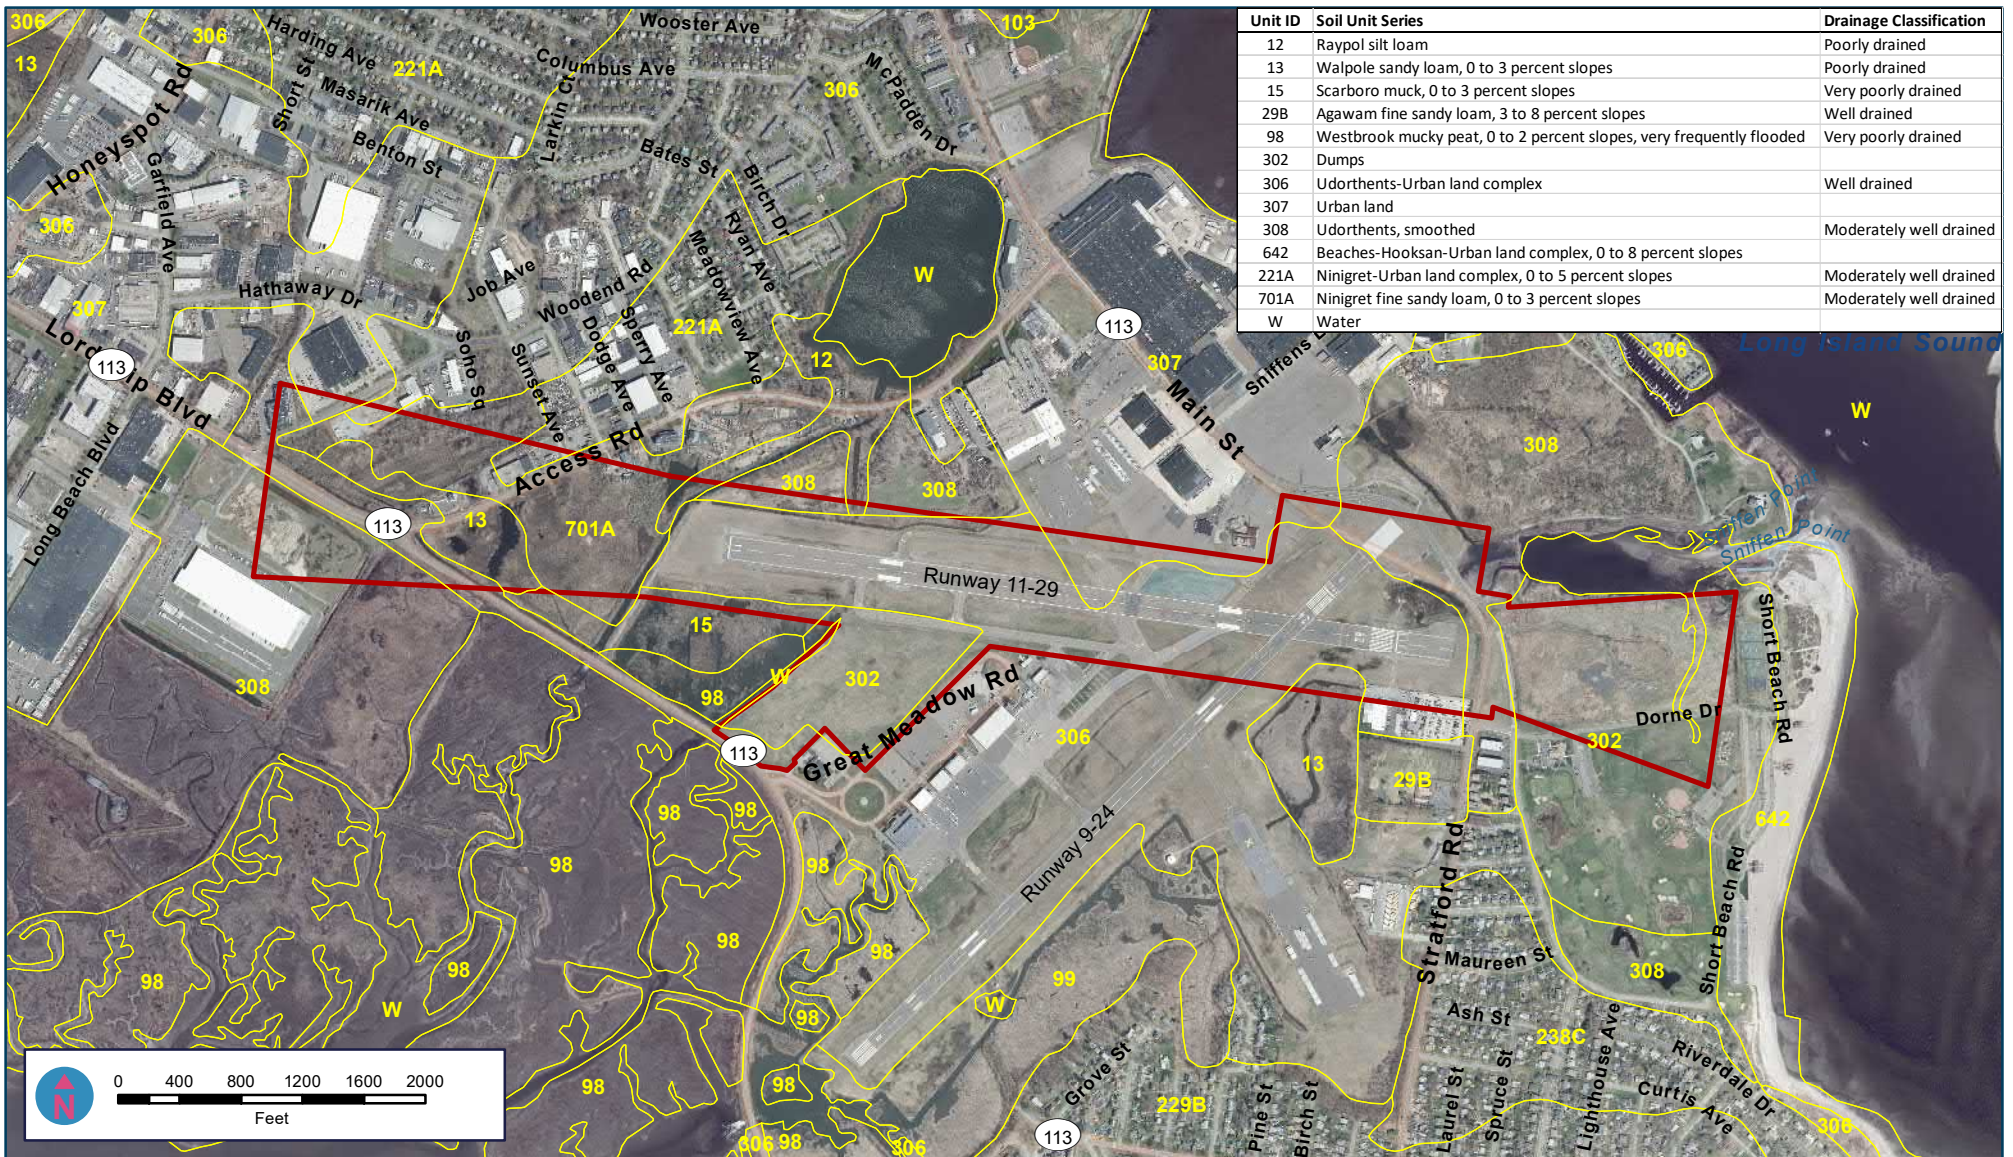
Figure 6 - NRCS Soils

The mapped NRCS soils and observed soils on, and in the vicinity of, the study area are depicted by their soil number on **Figure 6** in **Appendix A**. The mapped NRCS soils and observed soils within the study area are listed in **Table 2** along with their drainage class and NRCS official soil series description.

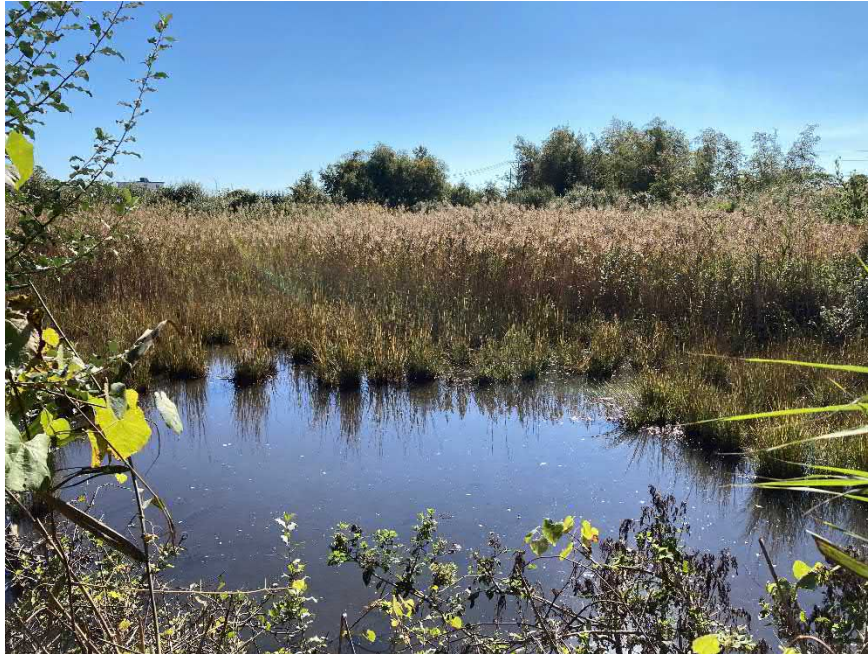
**Wetland 1, north central side (October 2021)**

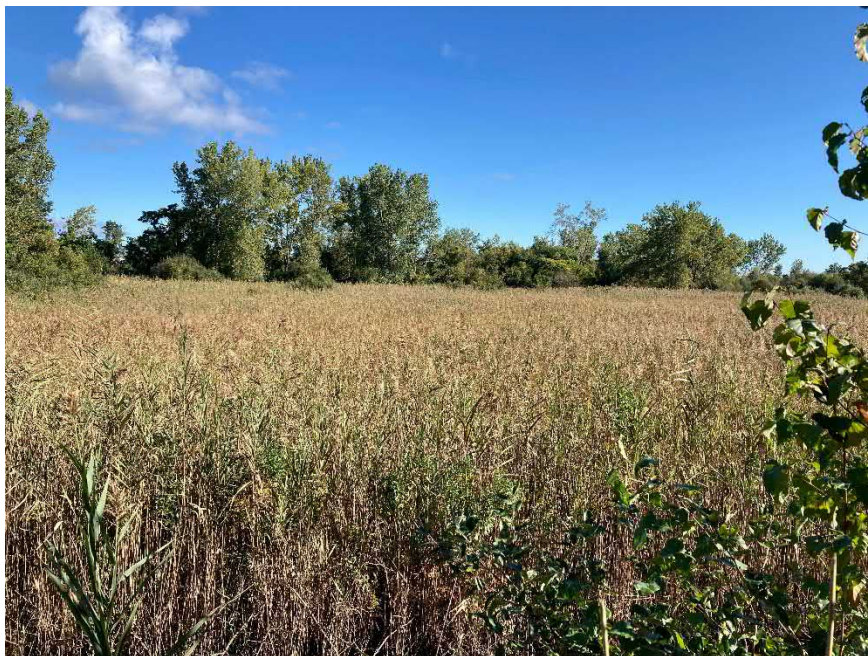
**Wetland 1, south side (October 2021)**

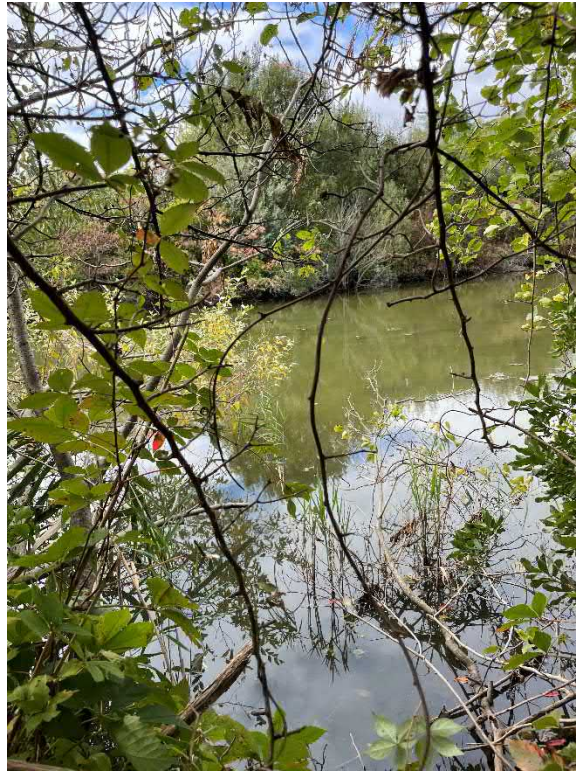
**Wetland 2 northeast side (October 2021)**

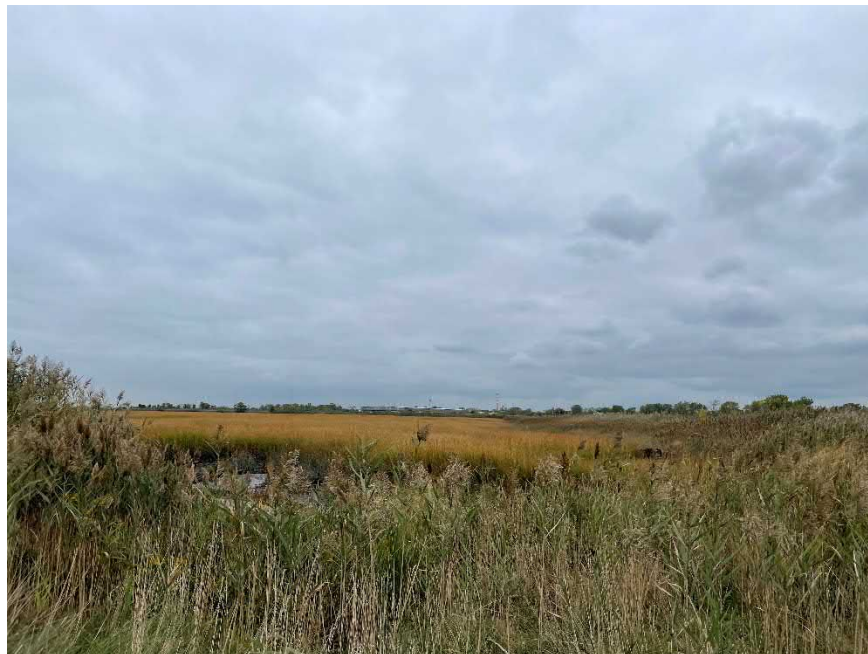
**Wetland 3 (October 2021)**

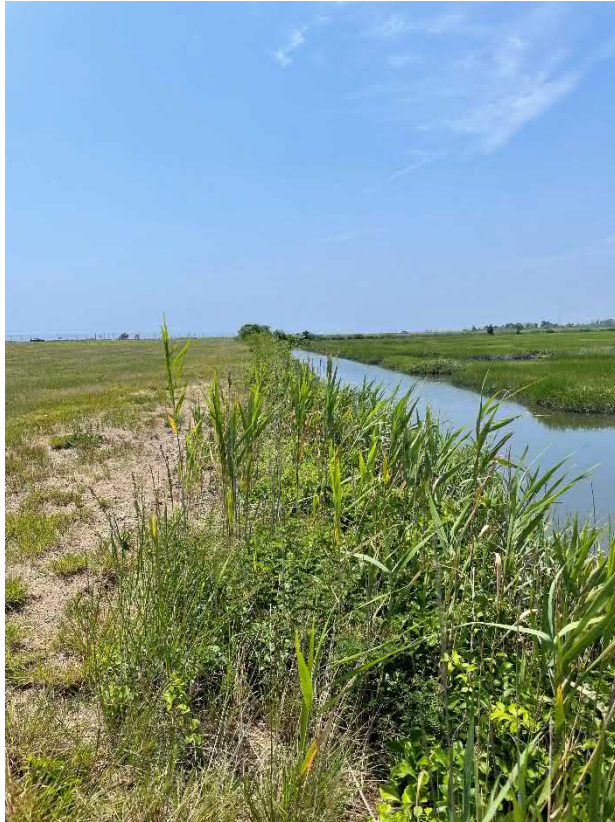
**Wetland 3, south side (October 2021)**

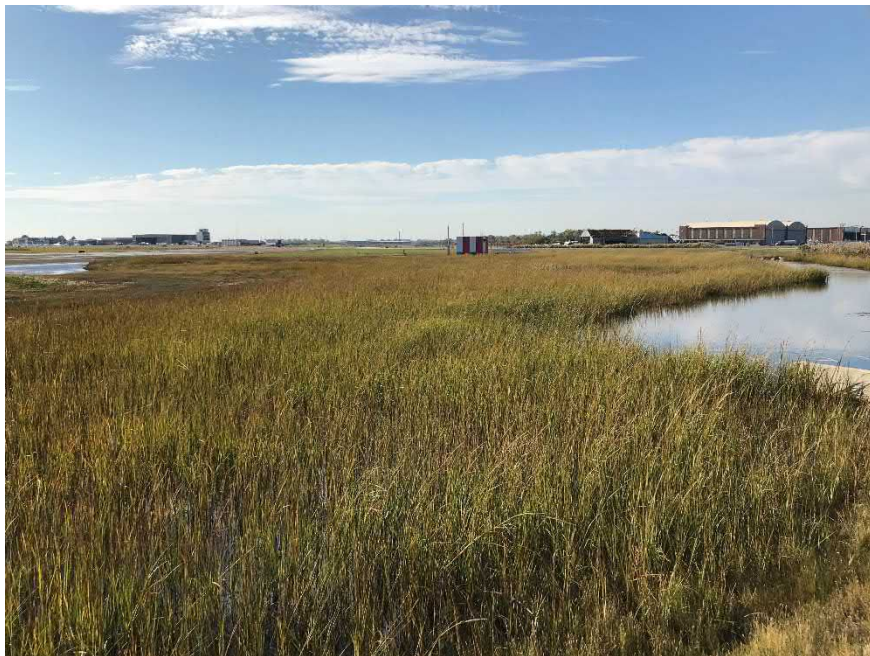
**Wetland 8 (October 2021)**

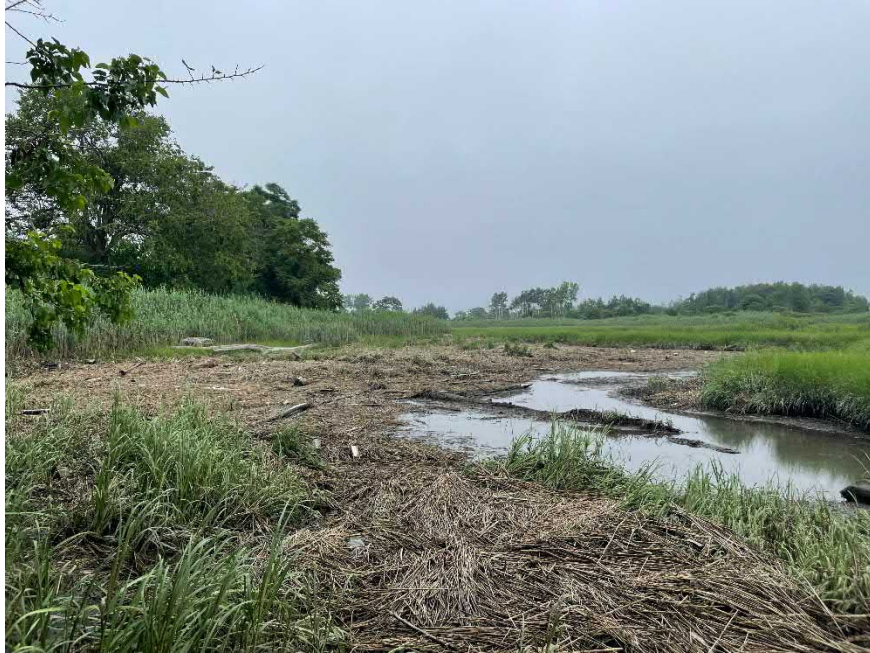
**Wetland 9, along south side of the Marine Basin (July 2021)**

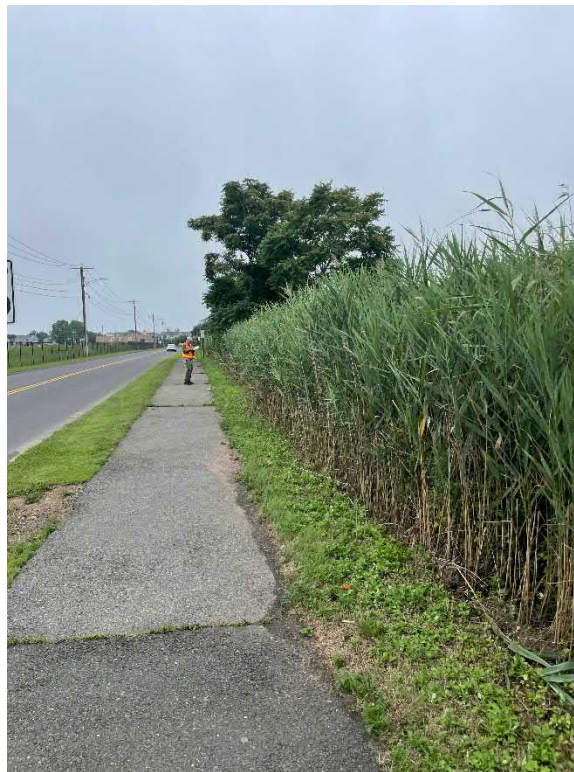
**Wetland 9, along the north side of Dorne Drive (July 2021)**
